INSPECTION REPORT

Report Number
SAMPLE

**3000 Johnson Blvd
Bloomington, Minnesota
55555**

PROPERTY INSPECTION REPORT

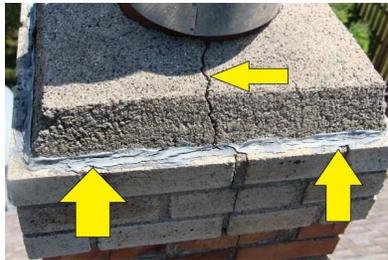
1

LOCATION: Chimney - Masonry **SYSTEM:** Roof

CONDITION: Masonry chimney cap is deteriorated

EXPLANATION: The chimney cap is required to secure the flue(s) and protect against water infiltration at the top of the chimney at the point where the flue(s) emerge from the chimney. The cap is observed to be in a deteriorated condition.

IMPACT/CONSEQUENCES: A damaged or deteriorated chimney cap may not be serving its intended function of preventing moisture infiltration. Water getting past the chimney cap can result in damage to the home's structure and interior. Moisture penetration past the cap may cause deterioration of the chimney's brick and mortar. A masonry specialist should be consulted to review, advise, and perform repairs as required.

RECOMMENDED ACTION: Repair

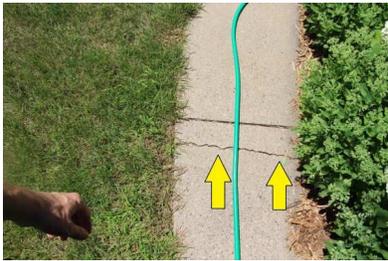
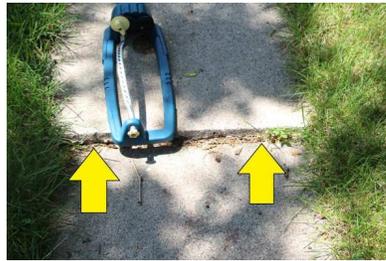
2

LOCATION: Exterior Rear **SYSTEM:** Exterior

CONDITION: Walking surface has settled or heaved

EXPLANATION: Settlement, heaving, or shifting of a walking surface is observed. Settlement, heaving, or shifting of the walking surface is often due to; poor grading and drainage, tree roots, the absence or poor configuration of gutter systems, saturation of the soil, soil type, or compaction issues. Indications of settlement, heaving, or shifting may include cracking, excessive slope, slope that does not promote drainage away from the foundation, excessive gaps between structure or sections of the walking surface, uneven surfaces, improper alignment with adjacent stairs, or general damage, or deterioration.

IMPACT/CONSEQUENCES: This condition may impair proper drainage and safe traversing of the walking surface. Settlement can result in water ponding on the walking surface, which will promote further deterioration over time. Low areas on the walking surface can result in ice patches in the winter, which pose a slip and fall hazard. Damage, deterioration, and uneven surfaces should be repaired to prevent possible trip hazards and allow for normal traversing of the walking surface. Gaps or open areas at expansion joints, should be repaired and or sealed to prevent water infiltration.

RECOMMENDED ACTION: Safety Concern | Repair, Replace

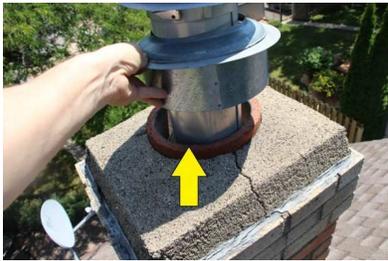
4

**LOCATION:** Chimney - Metal **SYSTEM:** Roof**CONDITION:** The flue collar is loose**EXPLANATION:** The loose flue collar can allow moisture on the outside of the flue that can run into the structure.**IMPACT/CONSEQUENCES:** Moisture running inside a chimney can cause deterioration to the flue and can leak back into the basement exit point. Unless repaired, there can be long-term damage to the structure.**RECOMMENDED ACTION:** Recommended Maintenance | Repair

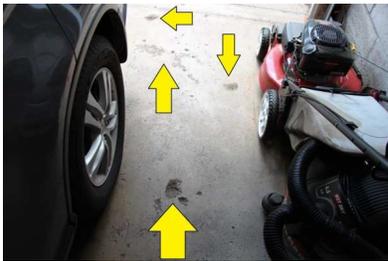
5

**LOCATION:** Garage Floor **SYSTEM:** Exterior**CONDITION:** Garage concrete floor displays pitting (minor)**EXPLANATION:** The concrete is pitted. The cause may be due to moisture and/or corrosive chemicals. There are companies that apply acceptable sealers on the concrete to slow or prevent this condition.**NOTE:** Many experts generally advise never to seal concrete with paint, epoxy coatings, or any coating that lays on the surface. Penetrating sealers are generally more highly recommended.**IMPACT/CONSEQUENCES:** Although this is primarily a cosmetic condition, proper cleaning or drainage may not be possible. The value for future use should be weighted against safety, use, and cost factors. Sealing the garage floor and cracks in the floor is recommended to help prevent further deterioration.**RECOMMENDED ACTION:** Review

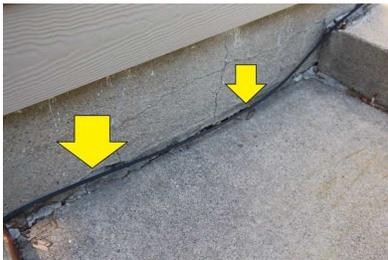
6

**LOCATION:** Exterior **SYSTEM:** Exterior**CONDITION:** There is cracking between the walkway and the foundation.**EXPLANATION:** Water that can penetrate below grade along the foundation can seep into the basement.**IMPACT/CONSEQUENCES:** The crack between the walkway and foundation wall must be filled to prevent a moisture intrusion path into the foundation.**RECOMMENDED ACTION:** Repair | Replace | Install | Consult Specialist

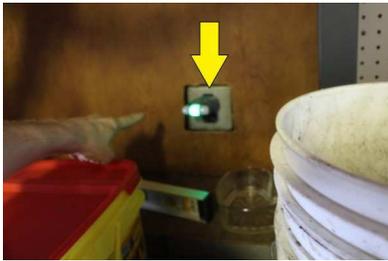
7

LOCATION: Garage **SYSTEM:** Electrical

CONDITION: GFI outlets are recommended at garage.

EXPLANATION: GFCI circuitry gives extra protection over a regular receptacle. Properly wired GFCI outlets are recommended at these locations to protect to people and equipment. Generally, it is advised to have all outlets within 6 ft of water and all outlets outside the heated walls of the house protected with GFI circuit protection.

IMPACT/CONSEQUENCES: The GFI receptacle is provided as a safety device in locations where the presence of water increases the risk of electrical shock. Generally recommended where a outlet is within 6 feet of an area that dispenses water (sinks, showers, tubs, laundry area, outlets under sinks for disposals or dishwashers) and all receptacle outside the heated walls of the home. Failure to correct this deficiency may result in serious injury and possibly death from electrical shocks should the device not operate when needed. Immediate repair, replacement, or installation is recommended.

RECOMMENDED ACTION: Recommended Safety Upgrade | Consult Specialist

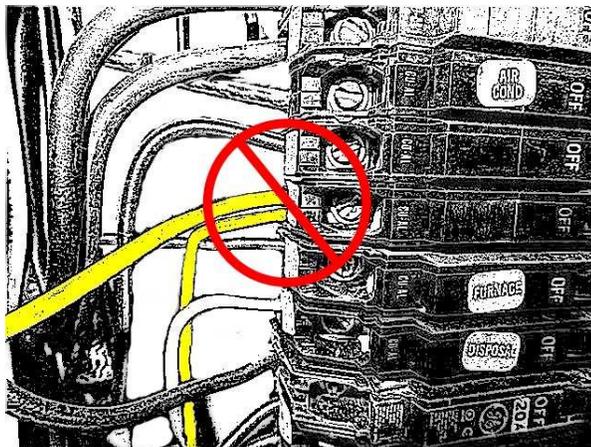
8

LOCATION: Basement **SYSTEM:** Electrical

CONDITION: Service panel has multiple wires connected to breaker or fuse (double / triple tapped)

EXPLANATION: It is observed that there is more than one wire connected to a breaker or fuse in the panel.

IMPACT/CONSEQUENCES: "Double tapping" or multiple tapping should not be practiced because the mechanical connection between the wire and terminal lug on breaker or fuse may not be technically secure with more than a single wire and/or the additional load on the circuit may cause arcing, excess resistance, over heating of breakers, fuses, or wires, etc. This condition is a safety concern and repairs performed by a Specialist should be a priority.

RECOMMENDED ACTION: Safety Concern | Consult Specialist

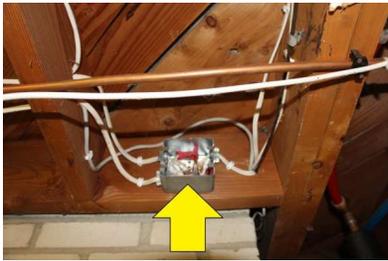
9

**LOCATION:** Basement **SYSTEM:** Electrical**CONDITION:** Exterior junction box cover plate is missing by chimney**EXPLANATION:** A protective cover plate is missing from an exterior electrical junction box.**IMPACT/CONSEQUENCES:** A cover plate for exterior junction box is required to reduce the risk of electrical shock and prevent infiltration of moisture and damage from pests. A suitable cover plate should be immediately installed for safety.**RECOMMENDED ACTION:** Safety Concern | Replace | Consult Specialist

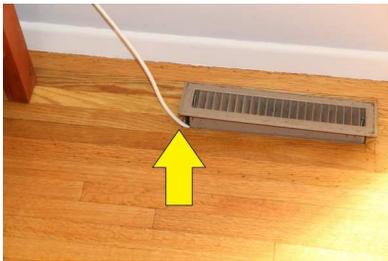
10

**LOCATION:** Living Room **SYSTEM:** Electrical**CONDITION:** Non-conforming wiring observed**EXPLANATION:** Wiring is observed to be done in a manner that does not appear to be in accordance to current standards. The cable wire is running through the supply register.**IMPACT/CONSEQUENCES:** Proper wiring methods are required. Consulting a specialist is recommended. Rerouting the wire is needed.**RECOMMENDED ACTION:** Safety Concern | Consult Specialist | Replace/Repair

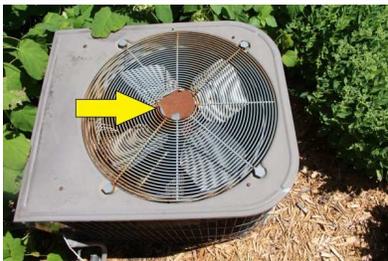
11

**LOCATION:** Air Conditioner **SYSTEM:** Heating/Cooling**CONDITION:** AC did not cool interior as expected**EXPLANATION:** The AC was not able to cool the interior of the home to an acceptable level. It may not be possible at the time of the inspection to determine the cause of this condition. Factors such as insulation, ventilation, vapor barrier, proper installation, and proper functioning of the furnace blower and ducting system may affect the ability to achieve satisfactory cooling.**IMPACT/CONSEQUENCES:** The general consequence is that satisfactory cooling to a room or area may not be possible until corrective actions are taken. A HVAC (heating/ventilation/air conditioning) specialist should be consulted to review and recommend solutions to this condition.**RECOMMENDED ACTION:** Recommend Evaluation and Course of Action Determined by Specialist

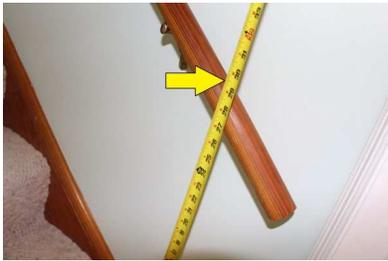
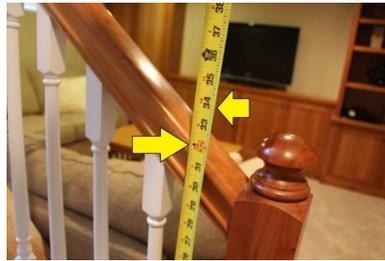
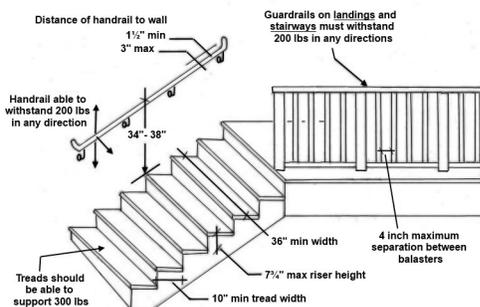
14

LOCATION: Various locations through out the home **SYSTEM:** Interior

CONDITION: Interior hand railing/guard is missing or non-conforming

EXPLANATION: This condition may be more common on older homes.

Handrails are recommended on stairs with two or more risers; both sides if stairs are over 44 inches wide, must be 34 - 38 inches above the stair tread nosing, must extend from directly above the bottom riser to directly above the top riser, be continuous for the entire length of a flight of stairs, ends be returned to the wall or terminate in a newel post, have a space of not less than 1½ inches between the handrail and the wall, must support a 200 lb. load, have a circular cross section of 1¼ inches to 2½ inches or equivalent with ⅓ radius edge (2X4 or other dimension lumber placed on edge or flat is not acceptable).

Guards are recommended to be a minimum of 36" high and are required for any porch, balcony, deck, or other raised floor surface located more than 24 inches above the floor or grade, be at least 34" high from the stair tread nosing and installed on the open side(s) of stairs with a rise of 16 inches+ above the floor or grade, have no openings greater than 4" or 6" at stair riser/tread/guard opening, be able to support a 200 lb. load applied in any direction.

IMPACT/CONSEQUENCES: The primary function of interior railings is to protect people from falling and being injured. There is indication of poor design, construction, or maintenance, such that the railings do not appear to be in a condition that meets its intended function of protecting people from the risk of injury. Failure to correct railing deficiencies is a safety issue, and in some cases may have legal consequences where a person is injured as a result of neglecting to provide adequate safety provisions.

RECOMMENDED ACTION: Safety Concern | Replace | Repair | Install

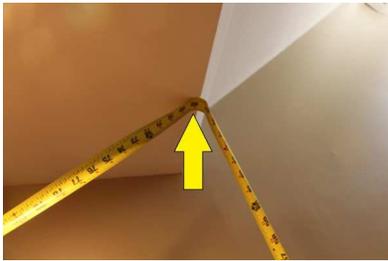
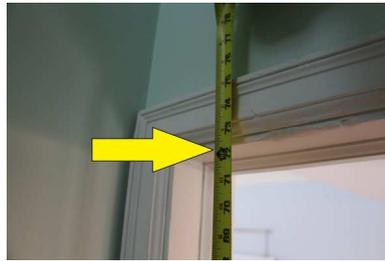
15

LOCATION: Stairway(s) **SYSTEM:** Interior

CONDITION: Ceiling height may be a safety concern

EXPLANATION: The ceiling height observed at the noted location may be a safety concern.

IMPACT/CONSEQUENCES: Although this condition may be typical in the attics, basements, and crawl spaces of many older homes, any low ceilings or “dropped” ceilings may cause injury and present a liability concern as well as a safety concern.

RECOMMENDED ACTION: Safety Concern | Review

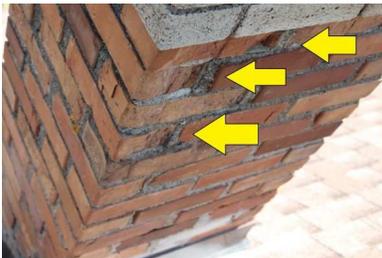
19

**LOCATION:** Chimney - Masonry **SYSTEM:** Roof**CONDITION:** Chimney masonry is deteriorated**EXPLANATION:** Deterioration of chimney brick masonry is observed.**IMPACT/CONSEQUENCES:** Brick masonry serves to support, enclose, and provide weatherproof protection of chimney flues. Brick masonry that is deteriorated will not meet its intended functions. Further and ongoing deterioration may result in costly repairs, and in some circumstances can be a safety concern. Repair by a masonry specialist is recommended.**RECOMMENDED ACTION:** Repair
