## Inspection Report

**Property Address:**  
9999 James Avenue  
Minneapolis MN 55555

**Branch Property Investigations**

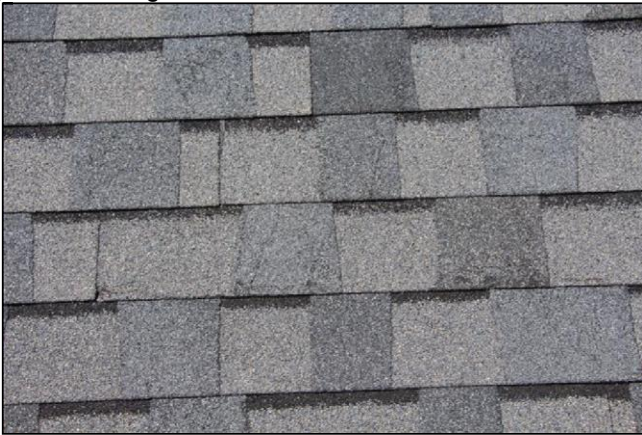
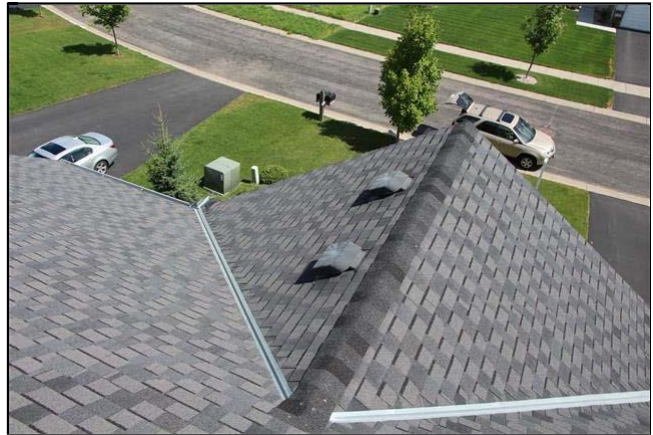
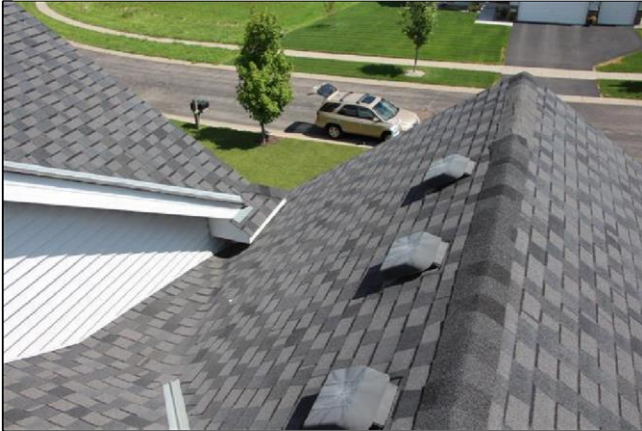
Asphalt shingles that were installed when house was built (2007) show wear and cracking consistent with nearly 10 year old shingles.

1.0 Item 1(Picture) Roof Condition

1.0 Item 2(Picture) Above Front Bedrooms

1.0 Item 3(Picture) Above Garage Roof

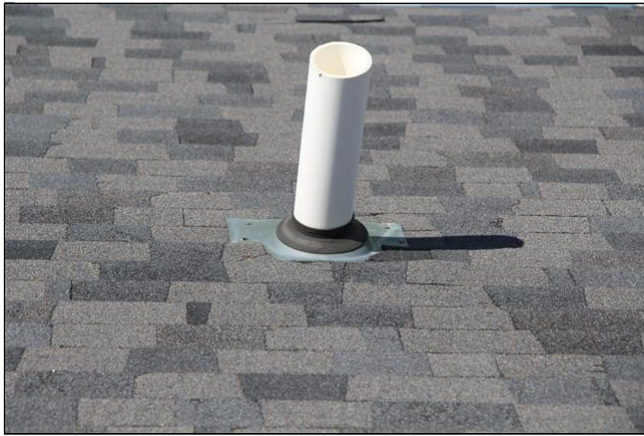
**Comments:** Inspected  
Vent rubber boots intact.

1.3 Item 1(Picture) Vent rubber boot

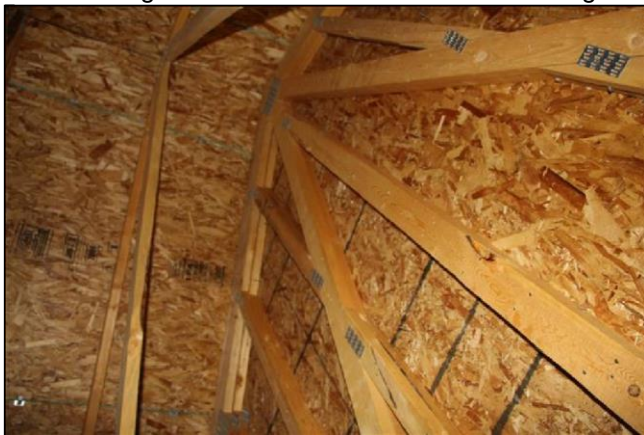
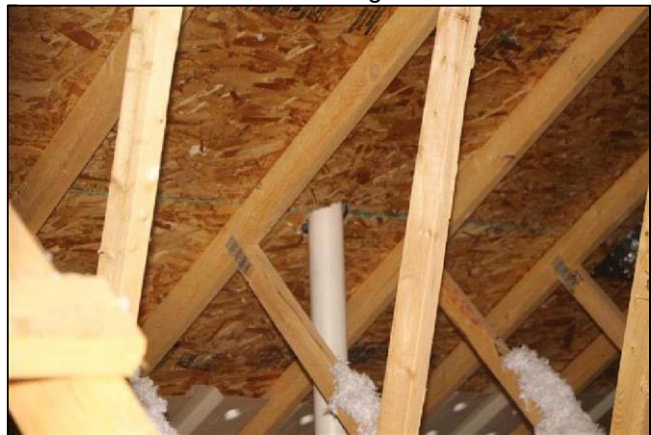
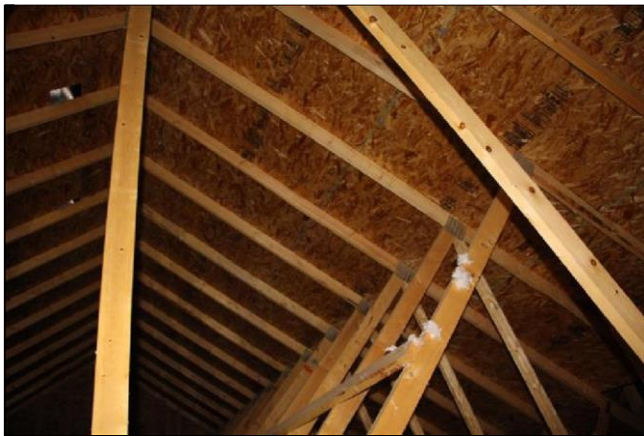
Attic Framing made of reinforced trusses. Decking is clear and there is no water staining from condensation or leaks.

1.4 Item 1(Picture) Attic End Wall

1.4 Item 2(Picture) Attic Framing Structure

1.4 Item 3(Picture) Attic along ridge

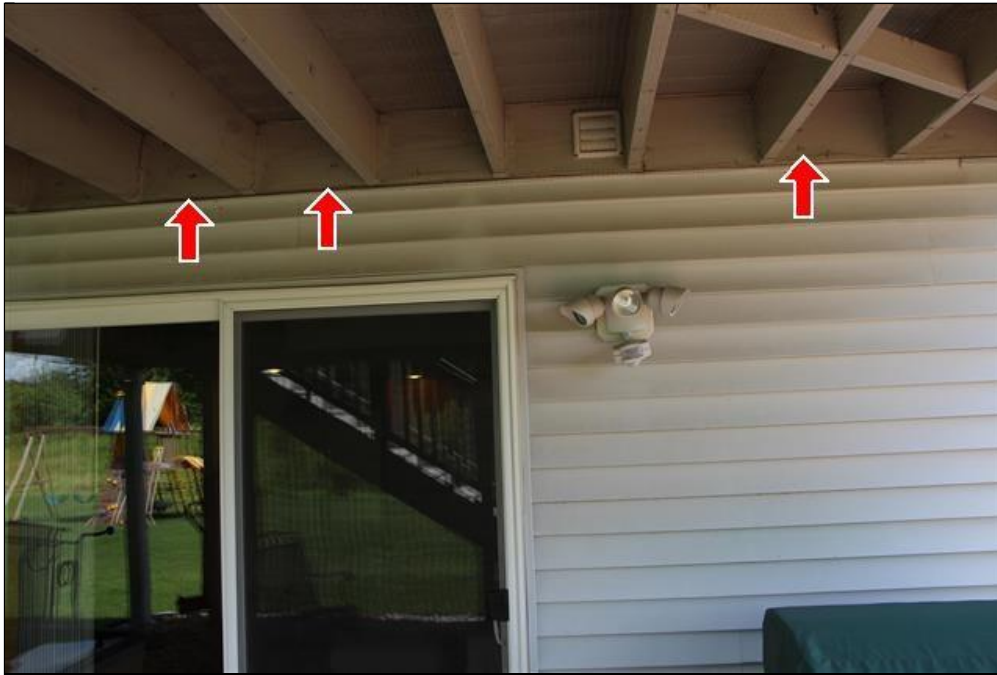
Deck appears to be attached with lag screws to the house rim joist at each joist bay. The joists are installed with the appropriate hangers. The above deck shade structure is not secured to the deck and pretty loose--removal is recommended. The play structure in the back has some deterioration in the canopy. If the structure will be used after purchase, I recommended careful inspection of all the connecting places due to its uncertain age.

2.4 Item 1(Picture) Deck Attachment to Framing: Lag Screws

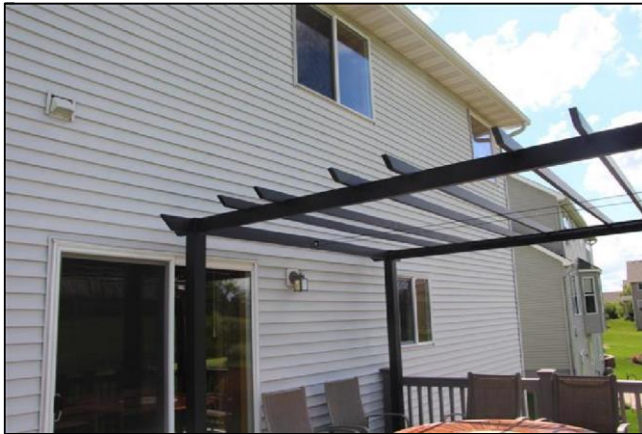
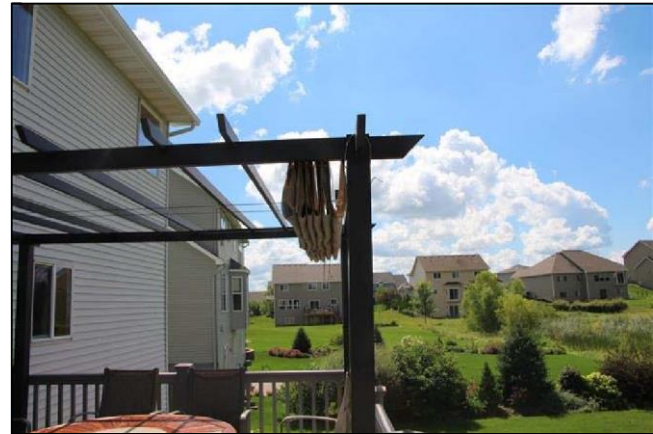
2.4 Item 2(Picture) Above Deck Shade Structure

2.4 Item 3(Picture) Above Deck Shade Structure

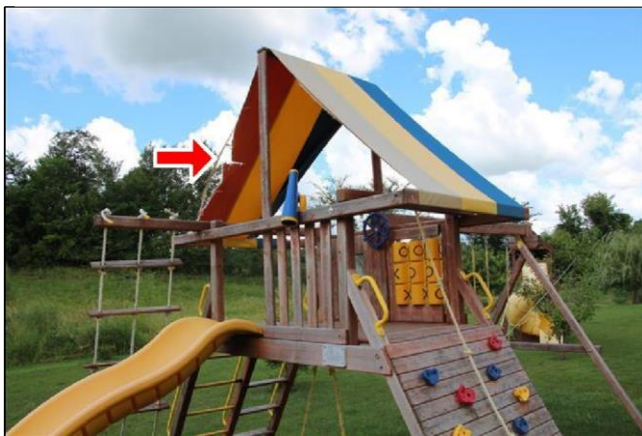
2.4 Item 4(Picture) Back yard play structure--Canopy torn

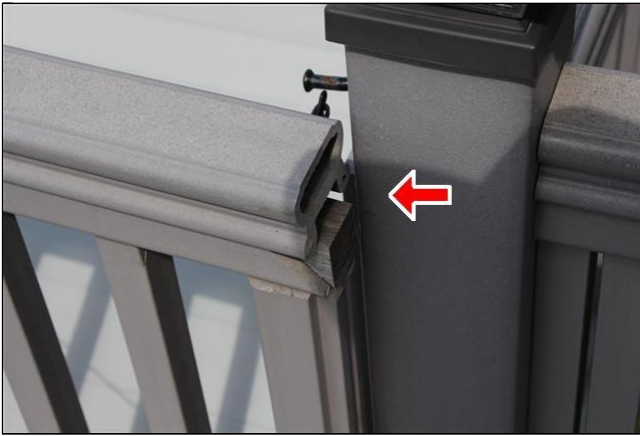
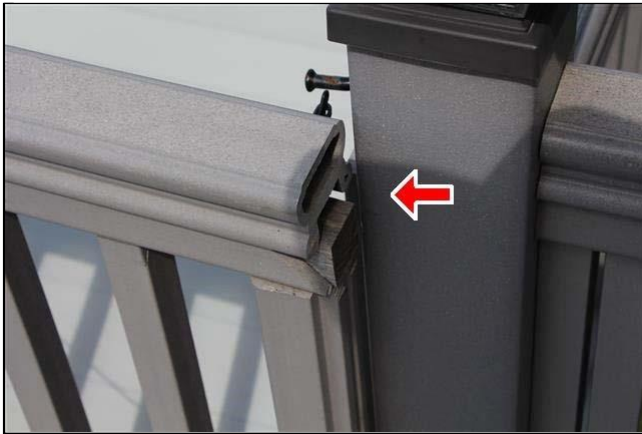
2.5 Item 1(Picture) Railing gate won't close

The deck railings are made of PVC, which provides a low maintenance solution for the railings. The gate to the deck stairs from the deck won't close without adjustment. Recommended adjusting gate closing mechanism so gate automatically closes for safety. The deck stringer paint is failing and repainting is recommended, this season if possible.

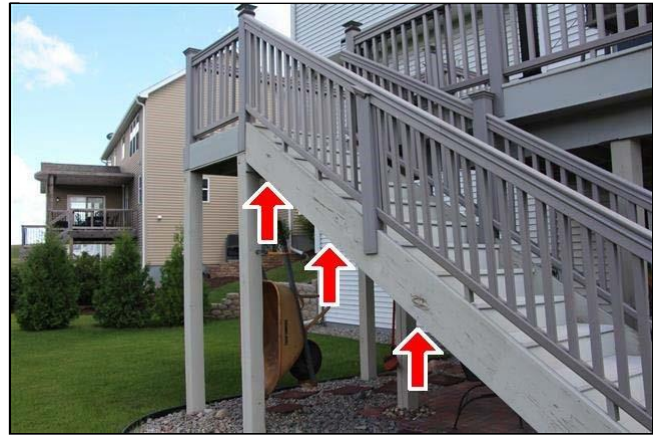
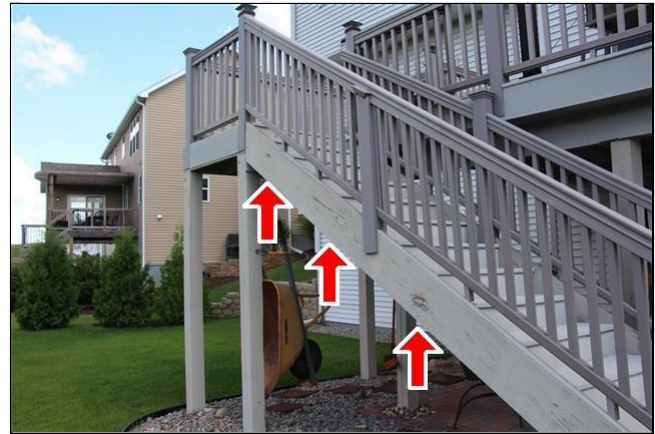
2.5 Item 2(Picture) Deck stringer paint failing

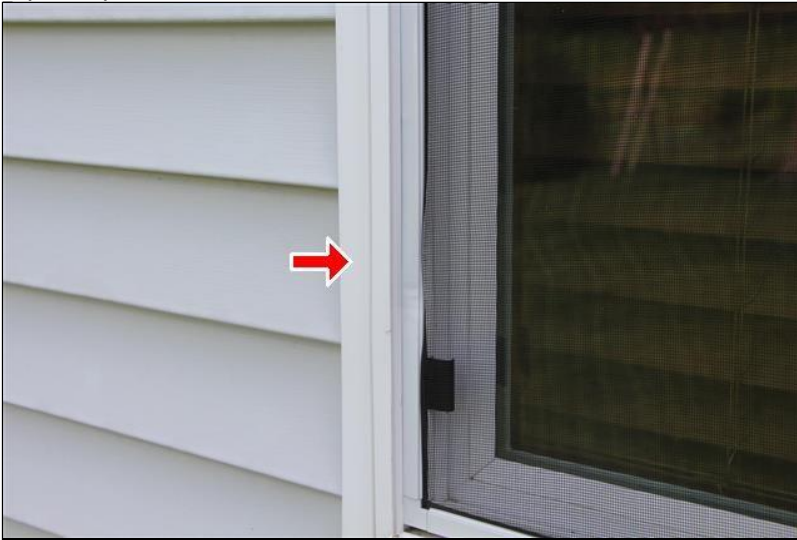
2.7 Item 1(Picture) Dented screen.

Repair/replace dented screen in bottom back window, furthest left when looking from back yard.

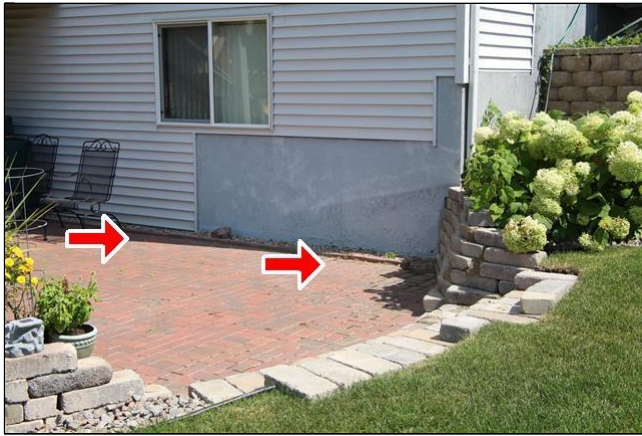
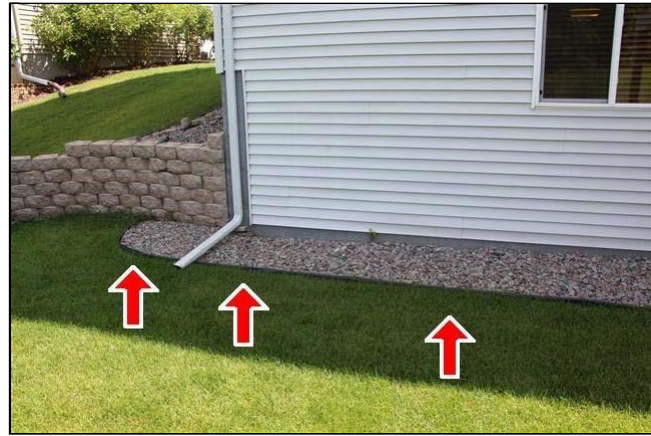
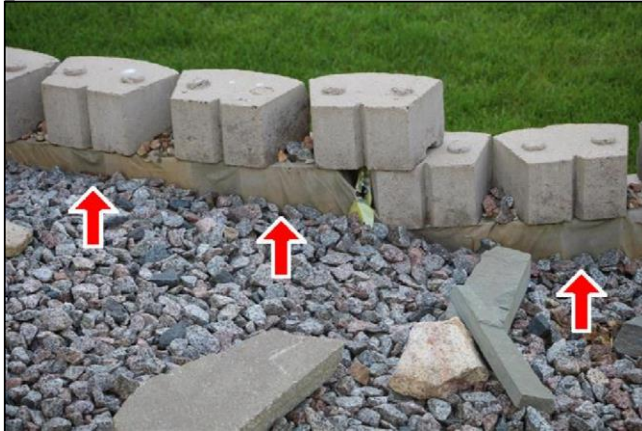
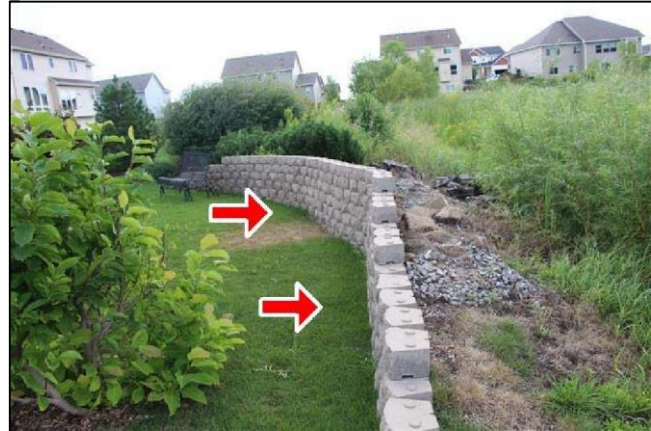
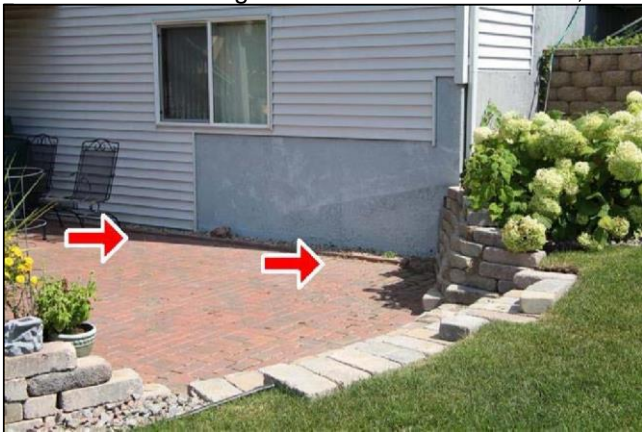
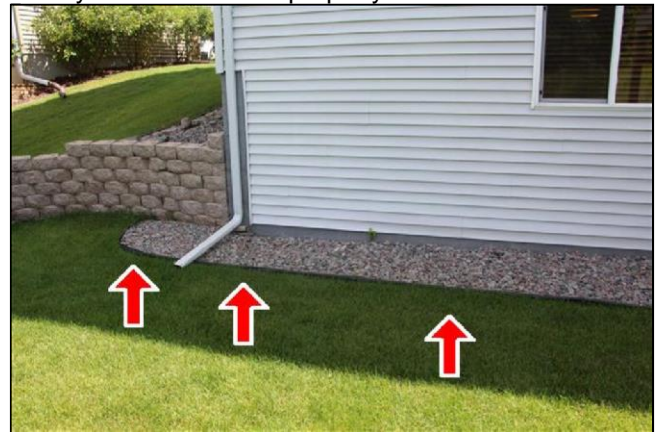
2.8 Item 1(Picture) Drainage concern--brick border

2.8 Item 2(Picture) Drainage concern--rubber border

2.8 Item 3(Picture) Drainage diverted around block

2.8 Item 4(Picture) Backyard keystone block wall used to retain dirt

Landscaping issues warrant further investigation. The brick border along the back portion of the brick patio and the black border on the other end of the house both impede water flow away from the house. The seller stated that water ponding in the backyard has not been an issue, so this is an advisory that it could be a concern in the future. The backyard retaining wall may not have sufficient strength based on the keystone block construction. I was unable to determine the footing or method of reinforcement, so there may be an issue if improperly installed.

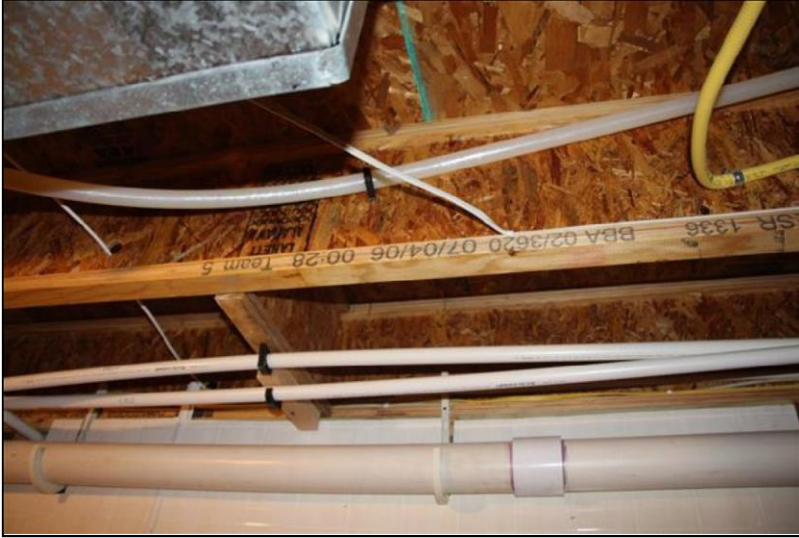
All observed framing structures appear in good condition and properly connected. There are pre-manufactured floor joists in the first floor framing.

3.4 Item 1(Picture) Floor Joists

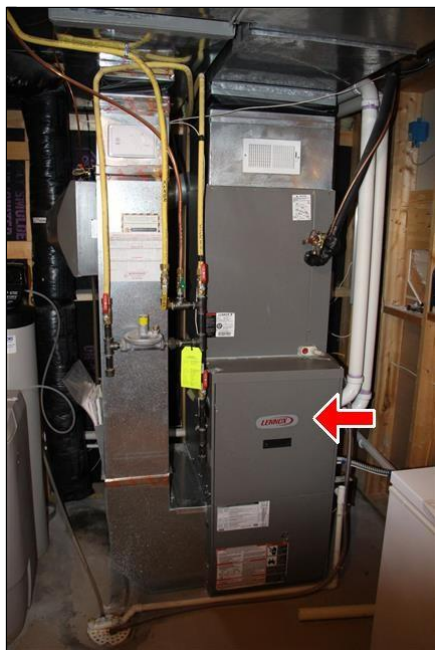
Lennox Heating & Cooling System original to house, 2007.

4.0 Item 1(Picture) Lennox Heating & Cooling System

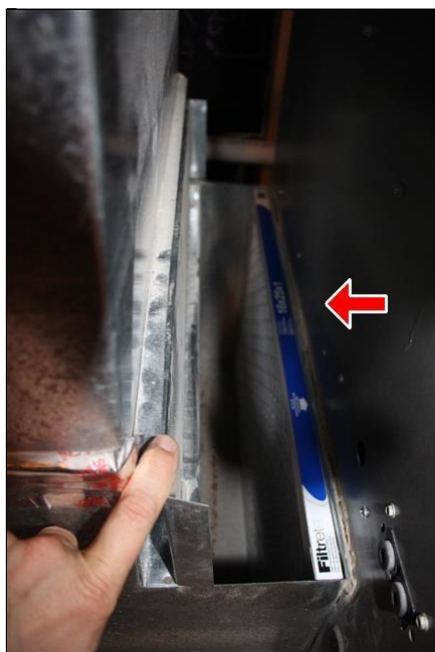
16" X 25" x 1" disposable filter.

4.3 Item 1(Picture) Disposable Filter

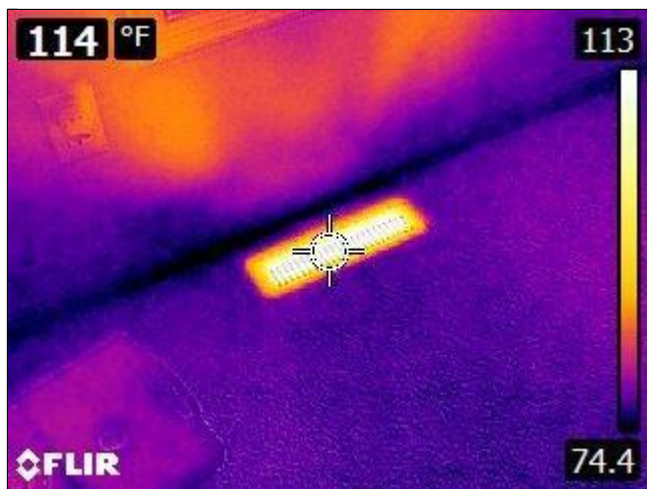
Heat system responds promptly to thermostat changes. Infrared images taken of each floor register.

4.4 Item 1(Picture) Infrared image is white (hot) showing floor register is distributing heat.

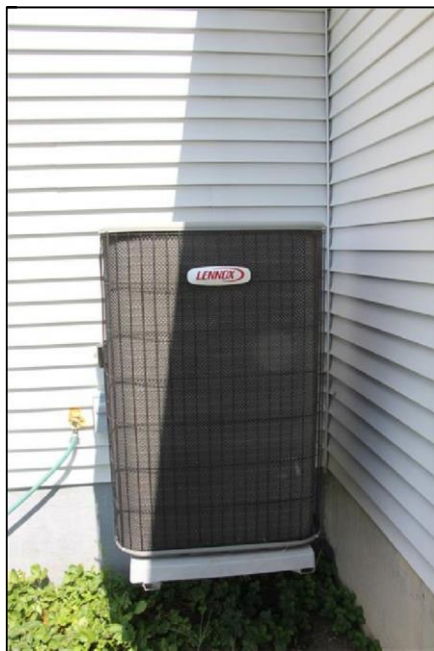
Inspected **4.6 Cooling System Comments:** Inspected Condenser located on on L side of house

4.6 Item 1(Picture) Lennox Condenser

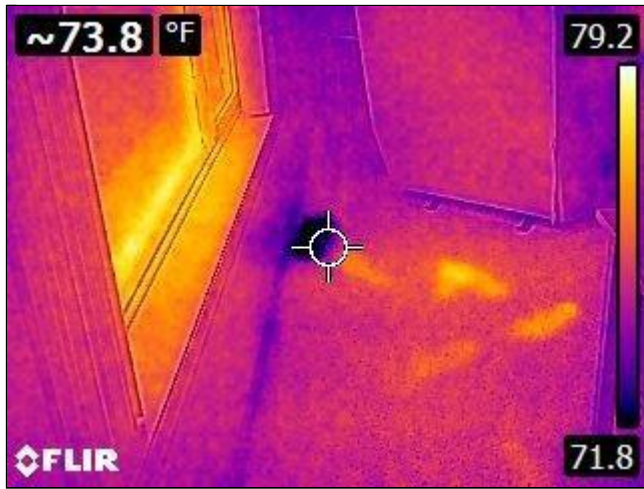
Each register was checked with an infrared camera and was providing cool air to the room.

4.8 Item 1(Picture) Infrared showing cool (dark) floor register

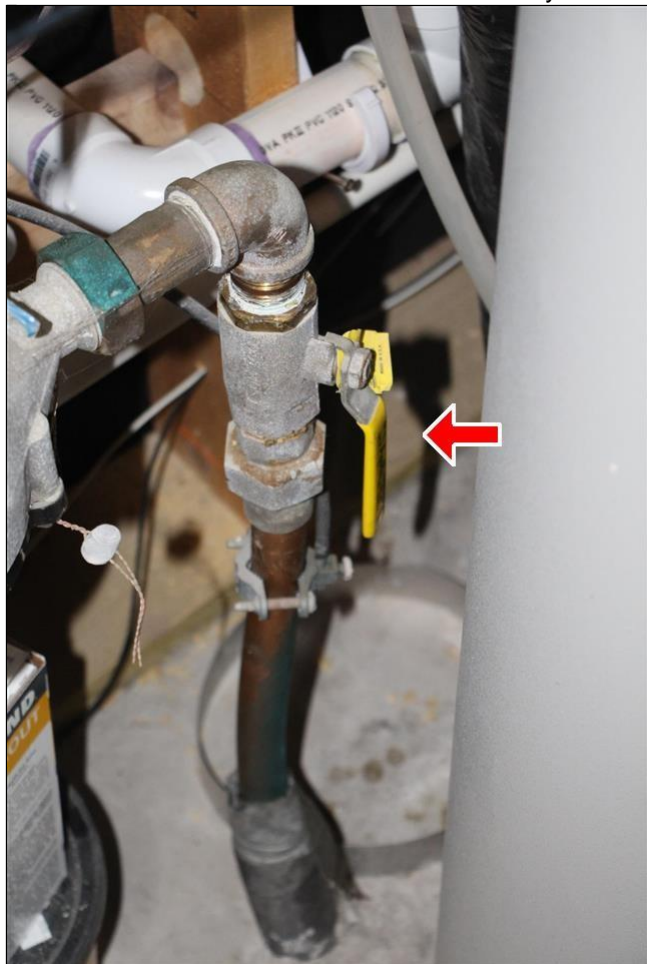
Yellow shut-off valve located in basement utility room behind water softener.

5.0 Item 1(Picture) Water shut-off valve

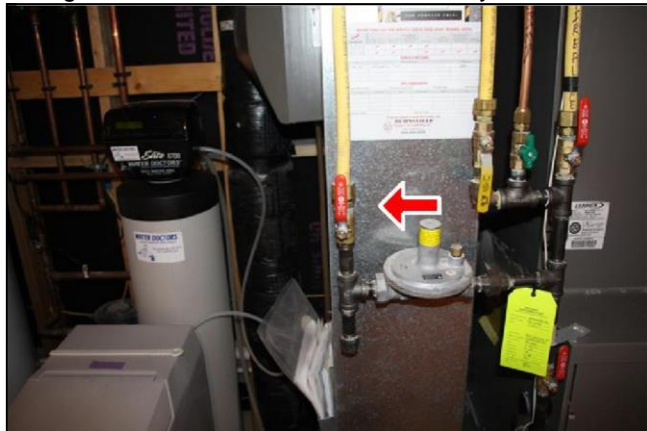
Main gas shut-off valve in basement utility room in front of furnace ducting.

5.1 Item 1(Picture) Gas shut-off valve

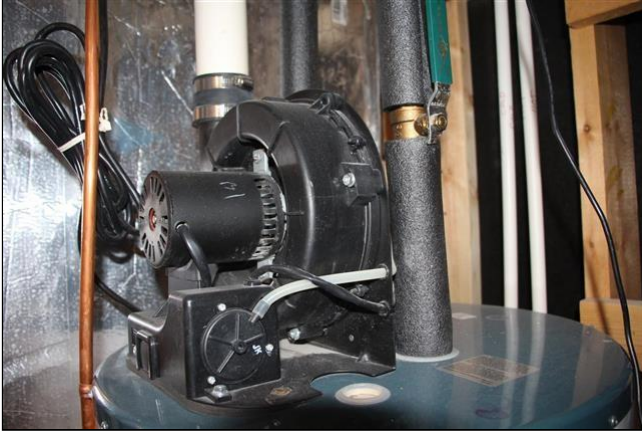
All working properly; no leaks observed.

5.2 Item 1(Picture) Water Heater Venting uses mechanical assist

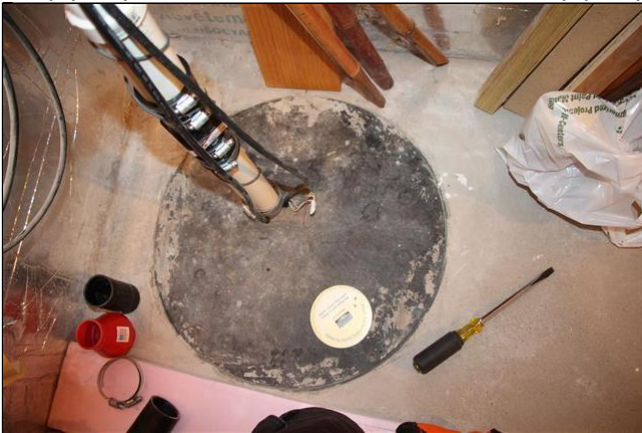
Sump pump cover was sealed closed. The sump pump did discharge during the inspection.

5.6 Item 1(Picture) Sealed sump pump cover

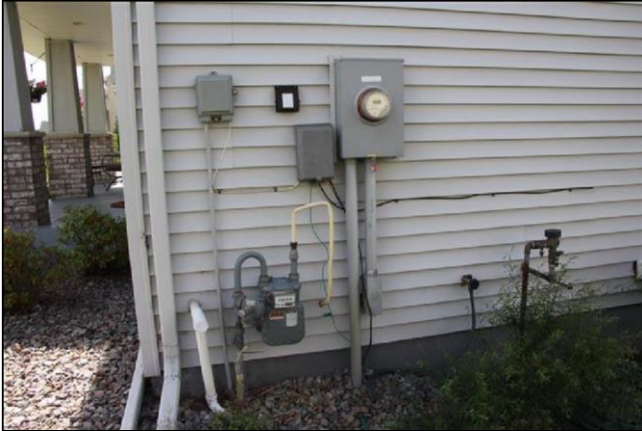
Underground service entrance.

6.0 Item 1(Picture) Service Entrance

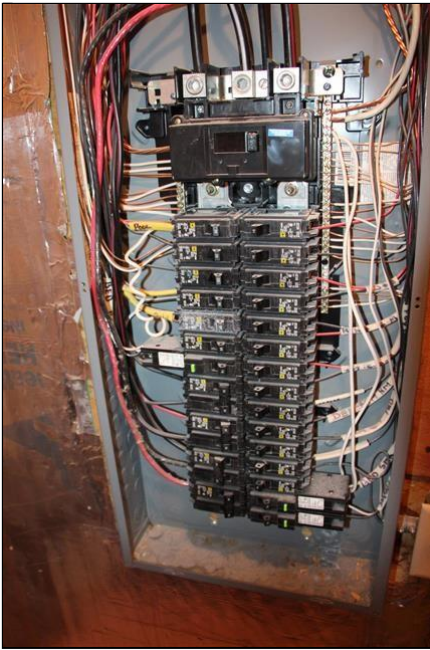
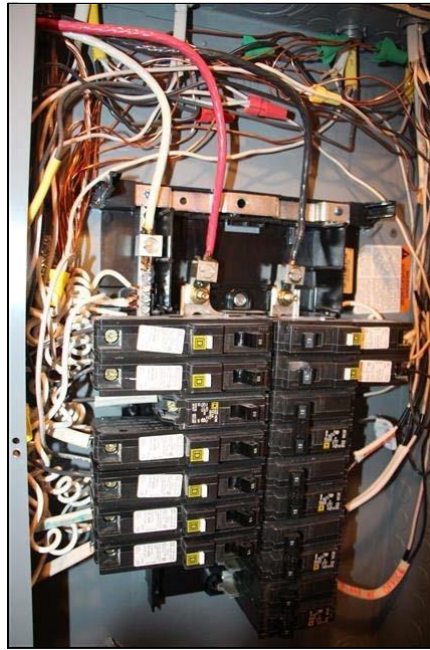
All circuit breakers are Square D. Wiring appears properly done.

6.2 Item 1(Picture) Main Panel

6.2 Item 2(Picture) Distribution Panel

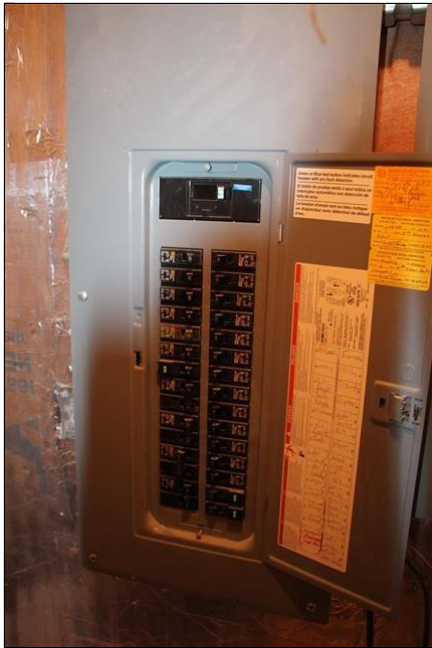
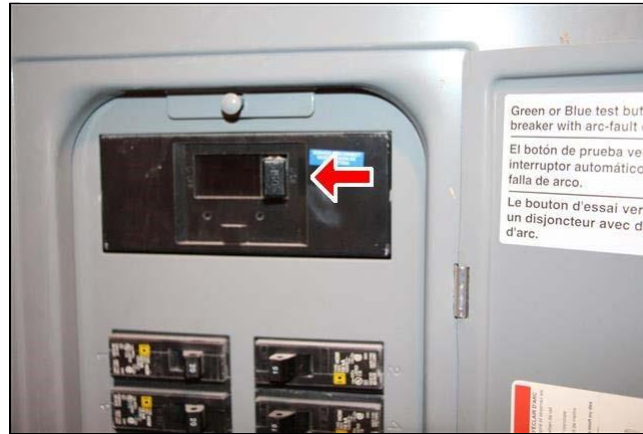
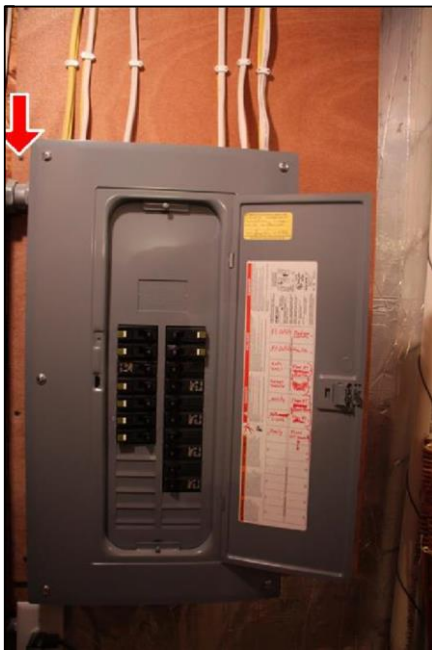
Main and Distribution panel are in basement closet at end of hall. Both panels shut-off by main breaker.

6.6 Item 1(Picture) Main panel

6.6 Item 2(Picture) 150 Amp service panel

6.6 Item 3(Picture) 2nd panel to R of main

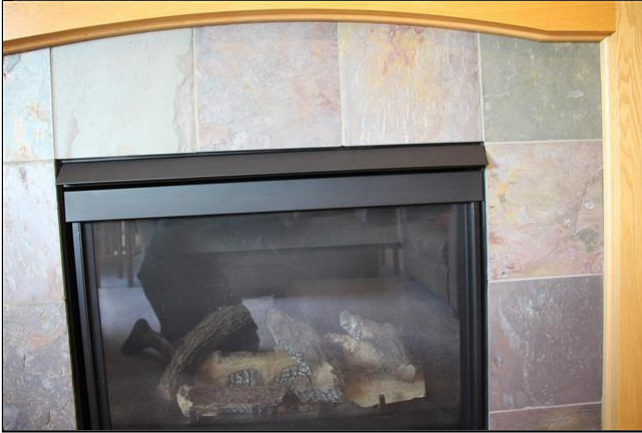
Fireplace is controlled by switch near entry to room (looks like light switch).

7.0 Item 1(Picture) Gas Fireplace

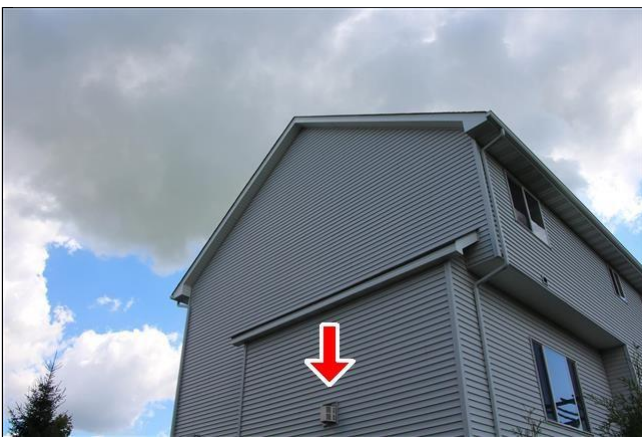
Fireplace flue is through wall of siding.

7.2 Item 1(Picture) Fireplace flue through wall

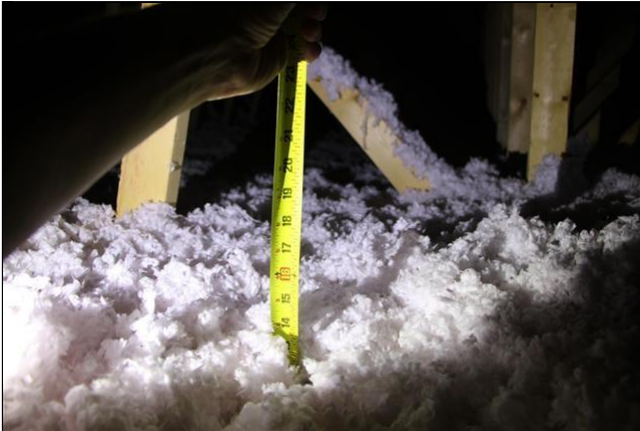
8.0 Item 1(Picture)

14-15" of blown-in insulation, which is right at the R-44 rating desired.

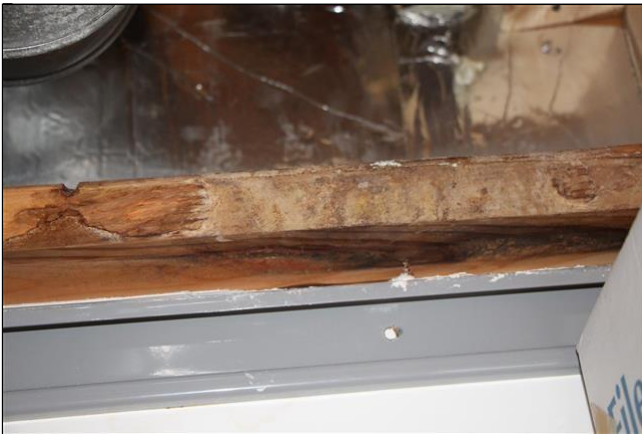
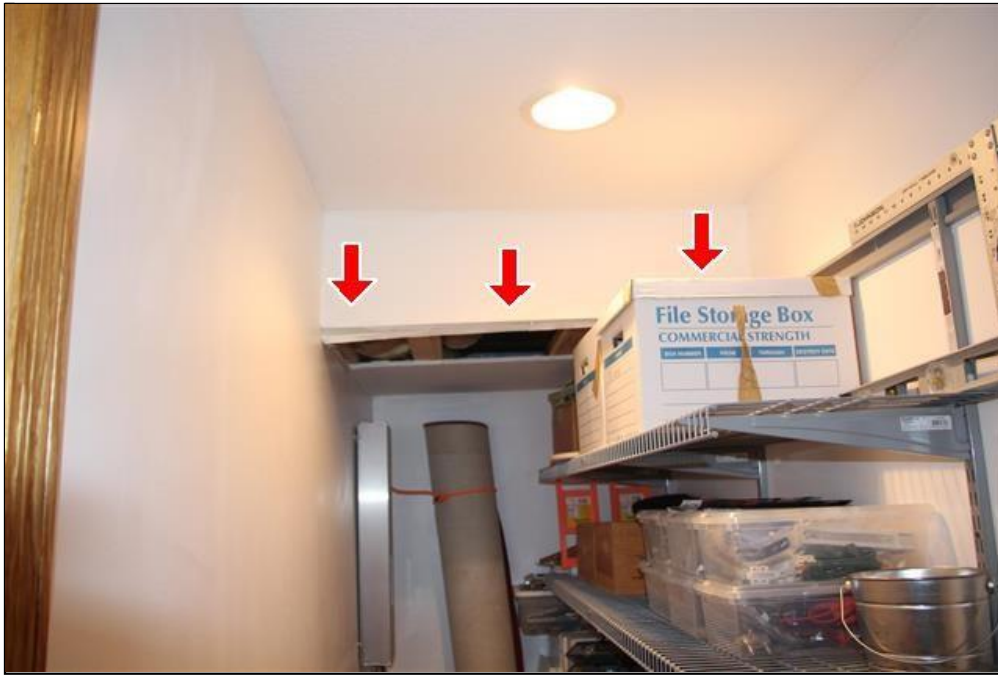
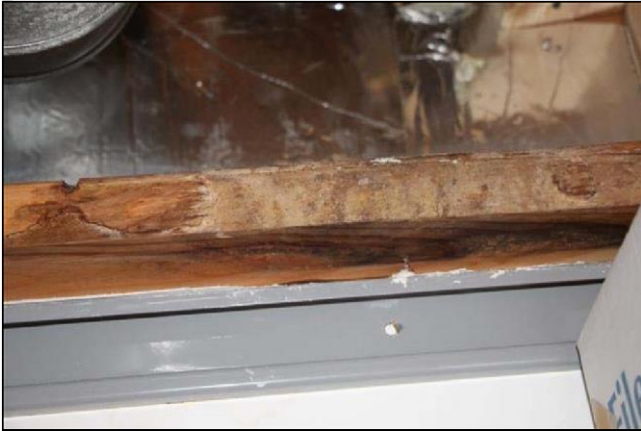
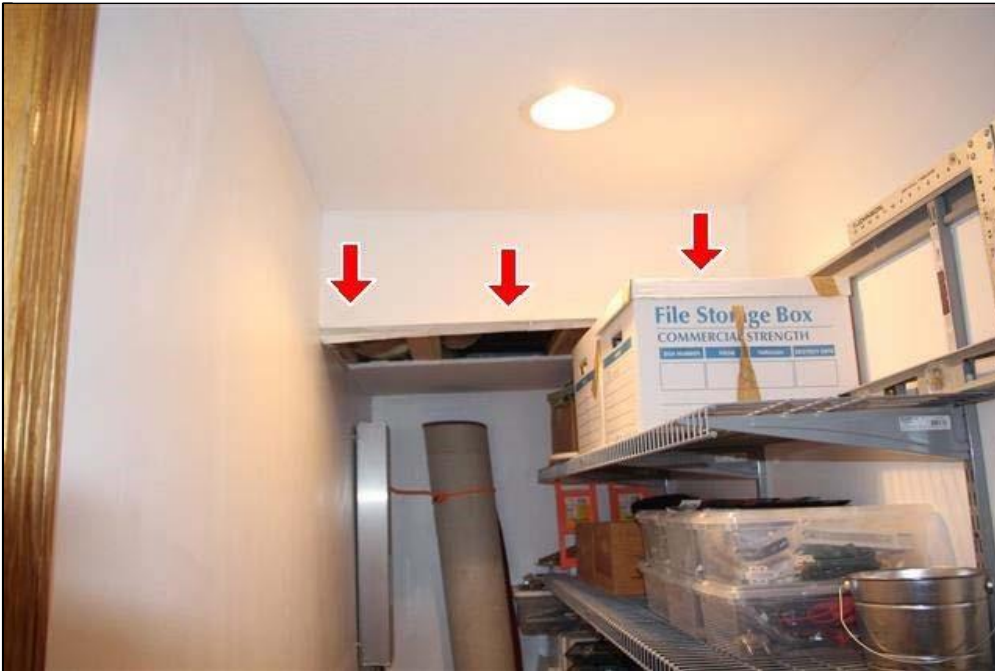
9.0 Item 1(Picture) Water staining & discoloration on ceiling framing.

9.0 Item 2(Picture) Water staining on drywall

Ceiling in back basement closet behind office had missing sheetrock. According to seller, a pipe froze and burst above this and has been left open to allow to dry out. Repair insulation to prevent pipe freezing (consider spray foam in this area), ensure pipes are shut-off and cleared prior to winter, and repair ceiling sheetrock, painting, and insulation.

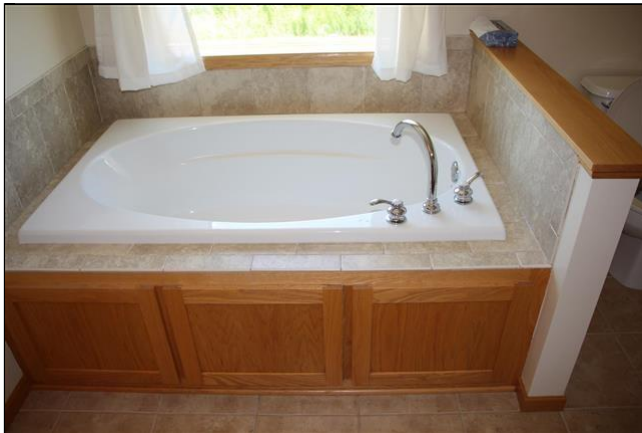
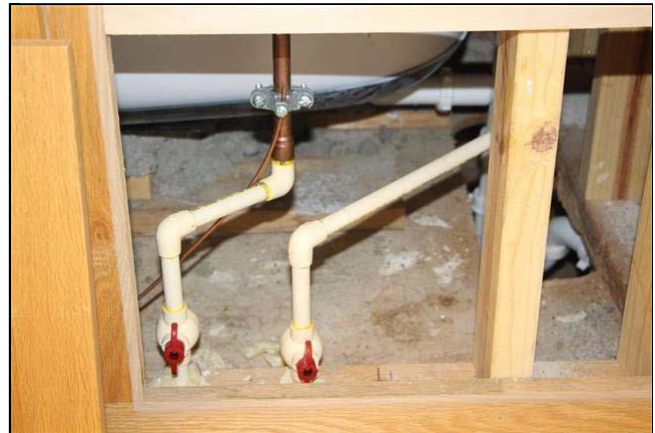
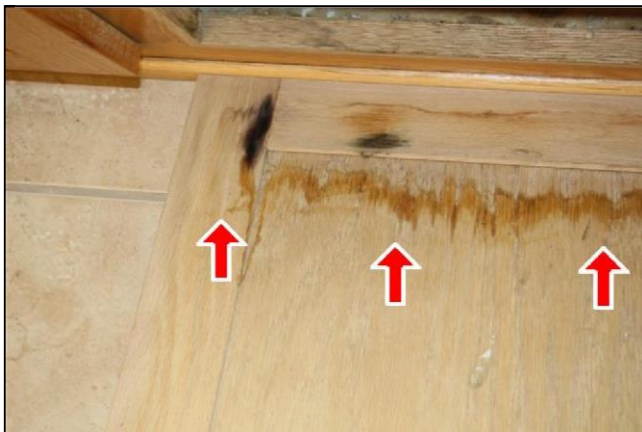
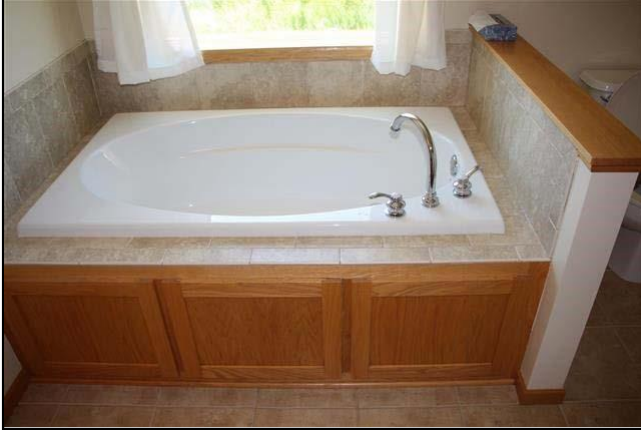
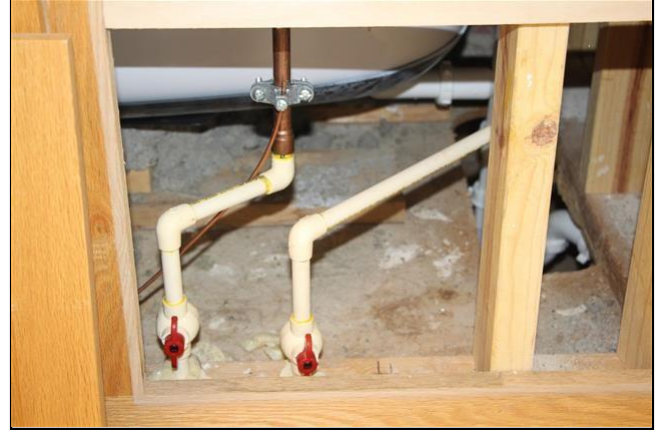
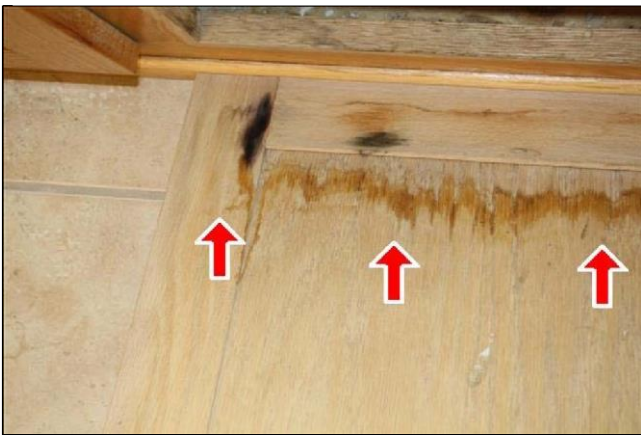
9.4 Item 1(Picture) Master Bathroom Tub

9.4 Item 2(Picture) Tub access area

9.4 Item 3(Picture) Black staining, water stains on tub access panel

Master Bathroom tub access panel has discoloration and water staining. This needs to be repaired or replaced to eliminate possible health hazard in home.

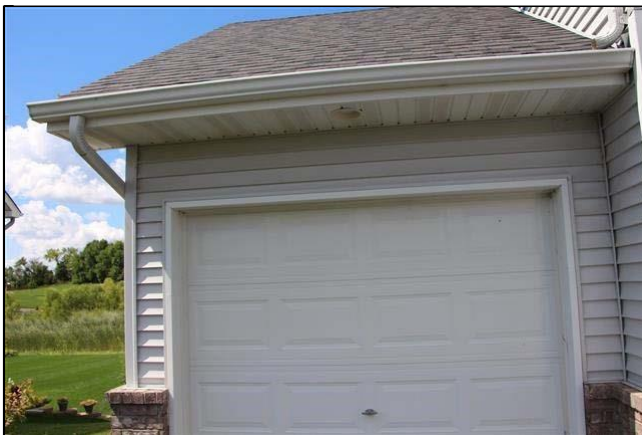
Inspected  
Metal garage door.

10.3 Item 1(Picture) Single Garage Door

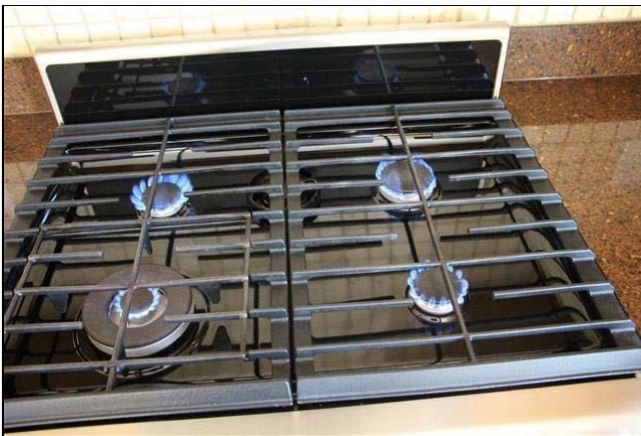
Tested operation of gas range; all four burners and oven operated.

11.1 Item 1(Picture) Gas burners work

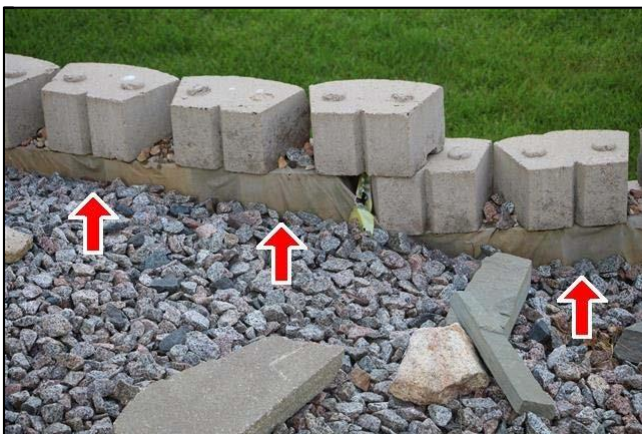
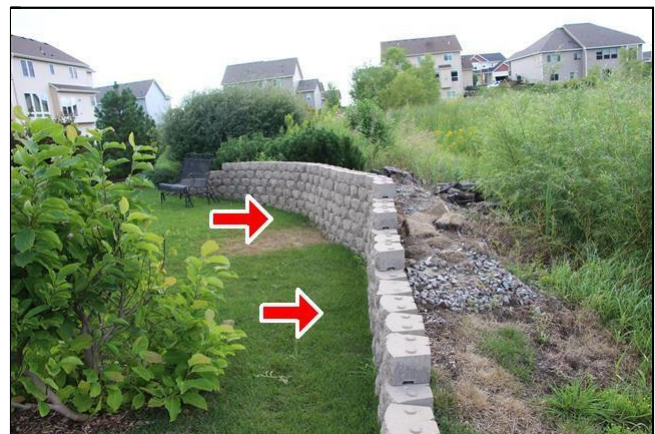
2.8 Item 3(Picture) Drainage diverted around block

2.8 Item 4(Picture) Backyard keystone block wall used to retain dirt
